Ozone and Ultraviolet Radiation Disinfection for Small Community Water Systems

EPA 600/2-79/060
July 1979

OZONE AND ULTRAVIOLET RADIATION DISINFECTION
FOR SMALL COMMUNITY WATER SYSTEMS

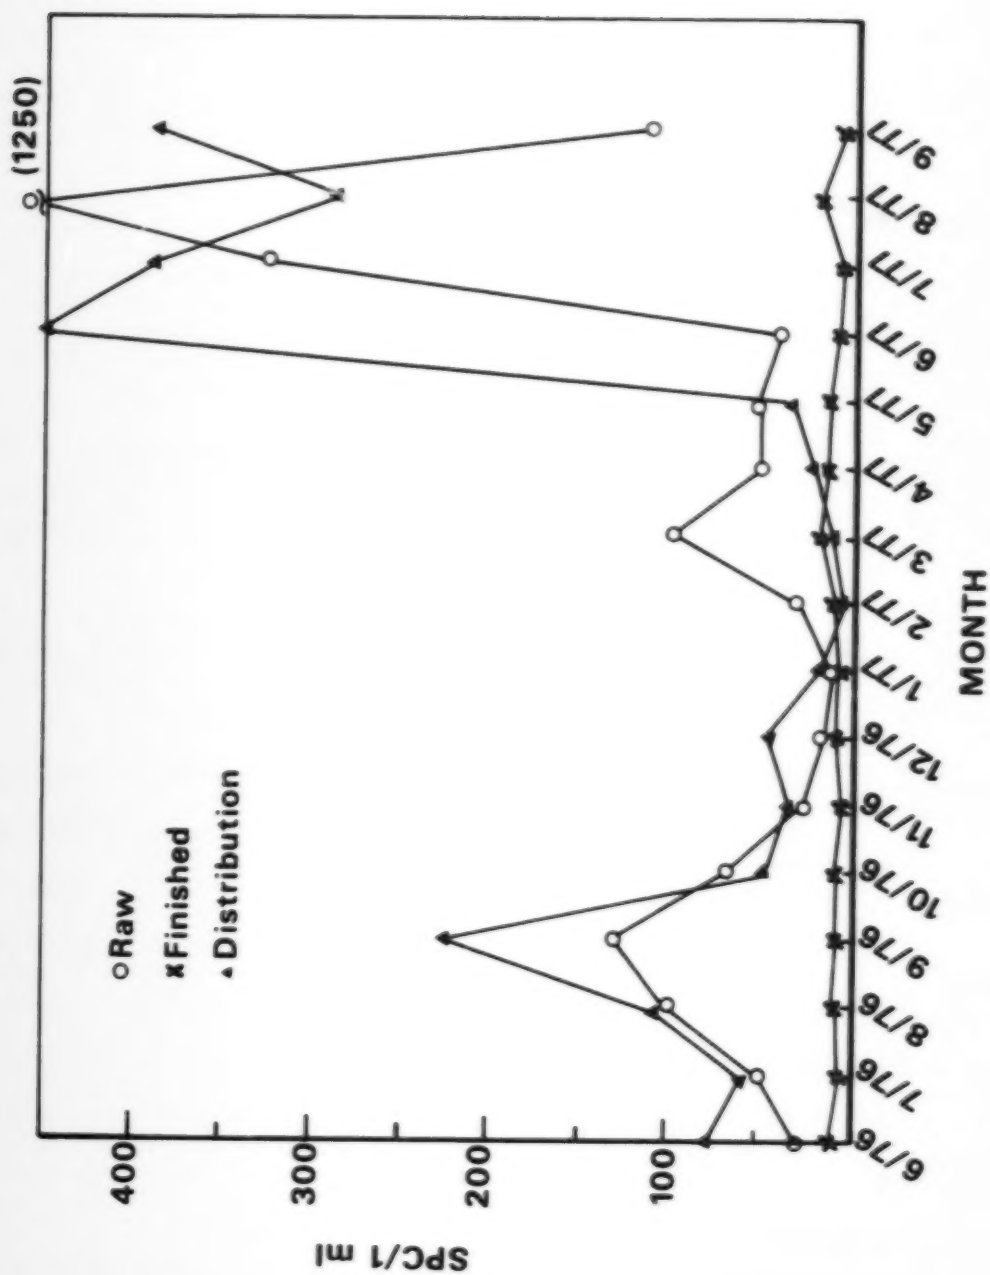
Monthly averages of standard plate counts are shown in Figure 1.

Figure 1. Monthly Standard Plate Count Average -- South Hero Fire District #1.

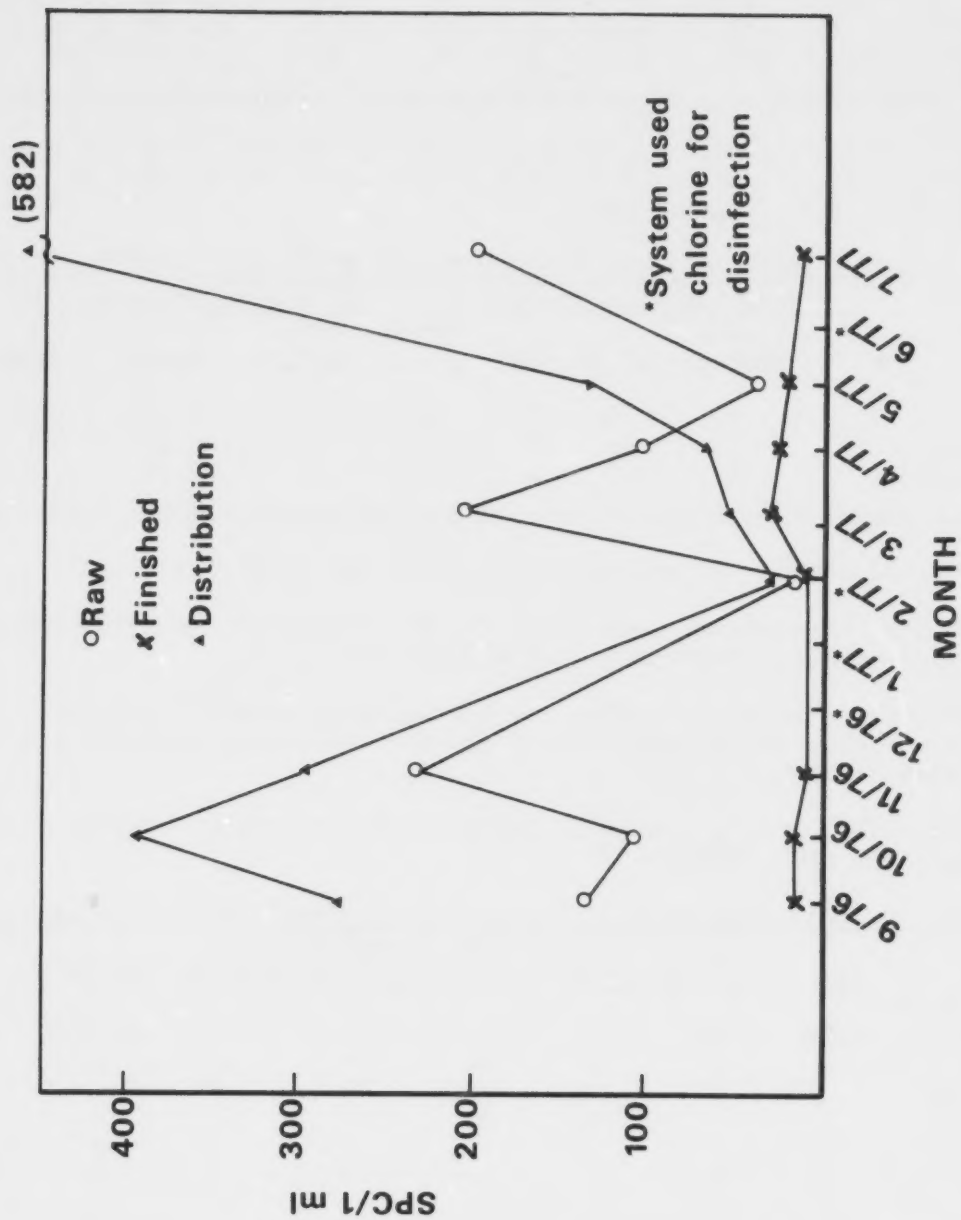
Figure 2. Monthly Standard Plate Count Average -- Grand Isle Water Supply Company.

Standard plate counts at this water system showed a similar pattern to those at South Hero Fire District #1. With increasing water temperatures, standard plate counts in the distribution system showed a marked increase. Using chlorine disinfection, no such increase was noted.

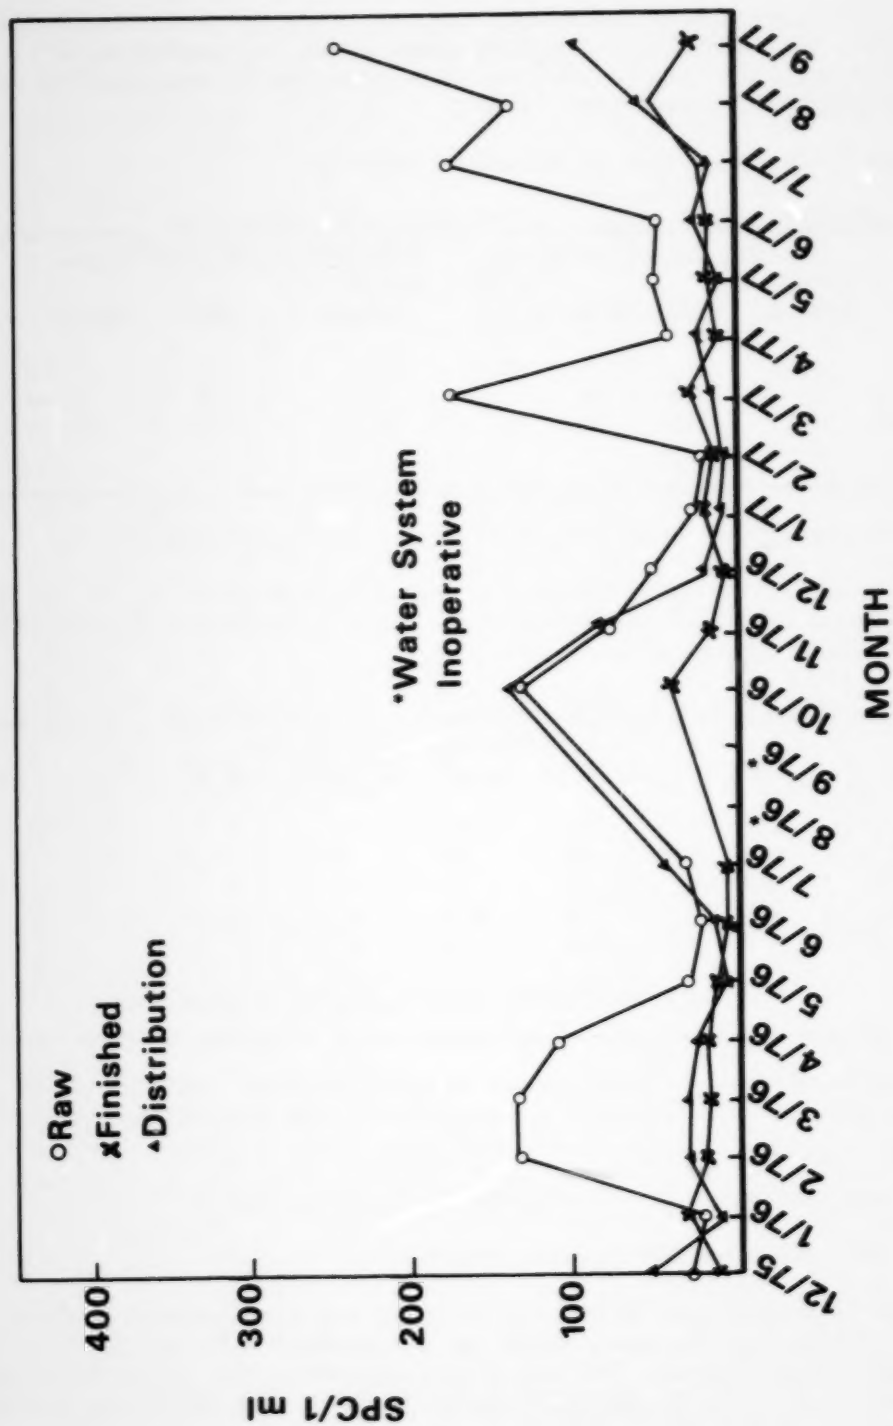
No significant trends were noted in standard plate counts in the distribution system. The highest counts were noted in October, 1976. This was just after the ultraviolet disinfection was reinstituted, and after some work had been done on the distribution network. There was a general rise in standard plate counts during the summer of 1977.

Figure 3. Monthly Standard Plate Count Average -- South Hero Fire District #2 North Shore.

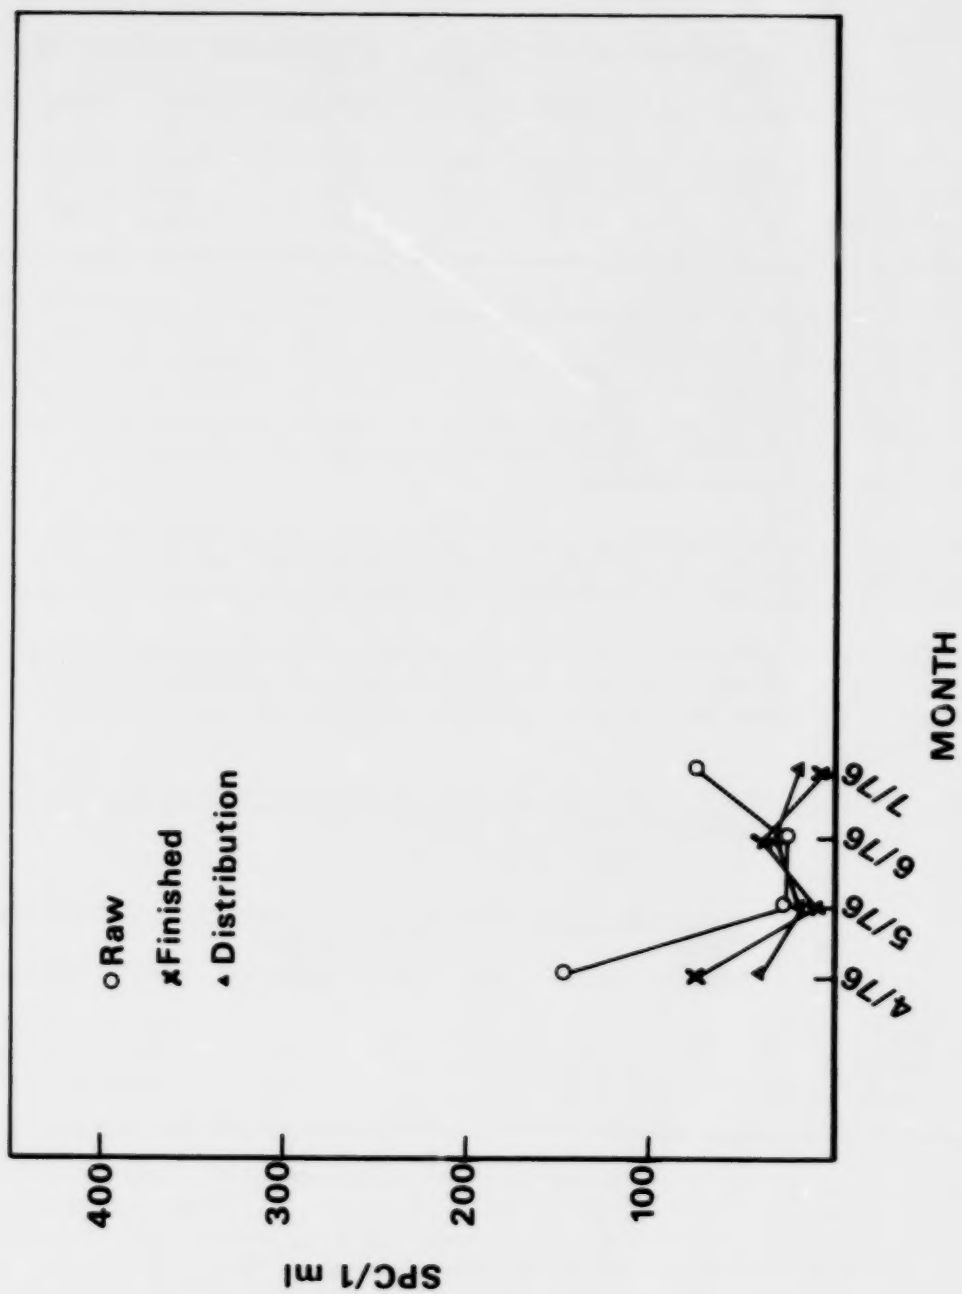
No trends were noted in standard plate count results.

Figure 4. Monthly Standard Plate Count Average -- Grand Isle Fire District #4.

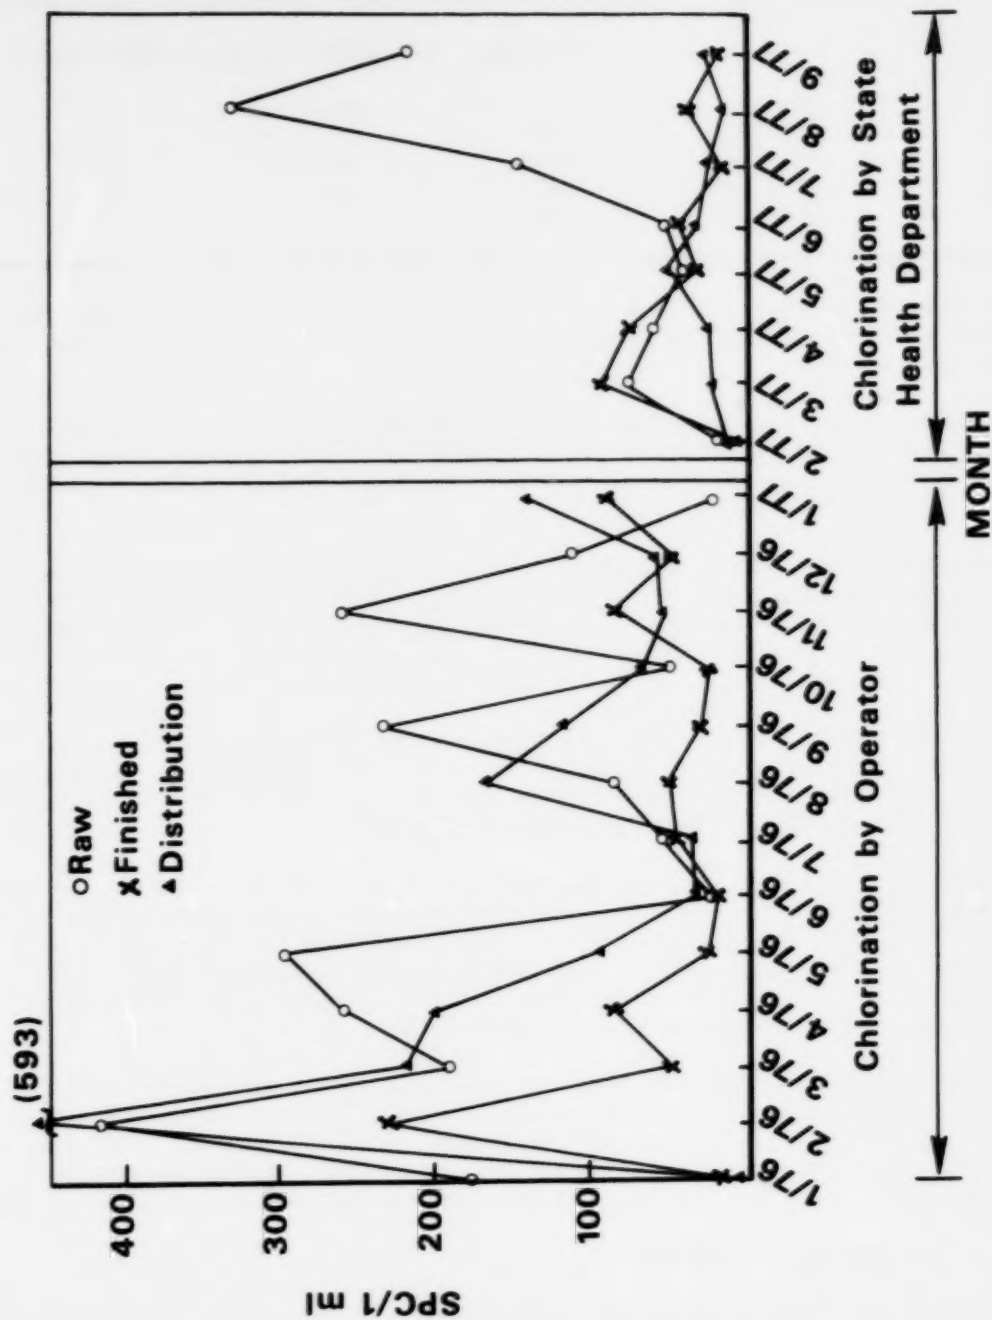
Figure 5. Monthly Standard Plate Count Average -- Grand Isle West Shore.
